1992: Campaign: Optispark Distributor

Subject: OPTI-SPARK DIST. (REPLACE WITH NEW P/N)

Model and Year: 1992 CHEVROLET CORVETTE W/ LT1 ENGINE

Bulletin Number: 92C11 - (06/15/1992)

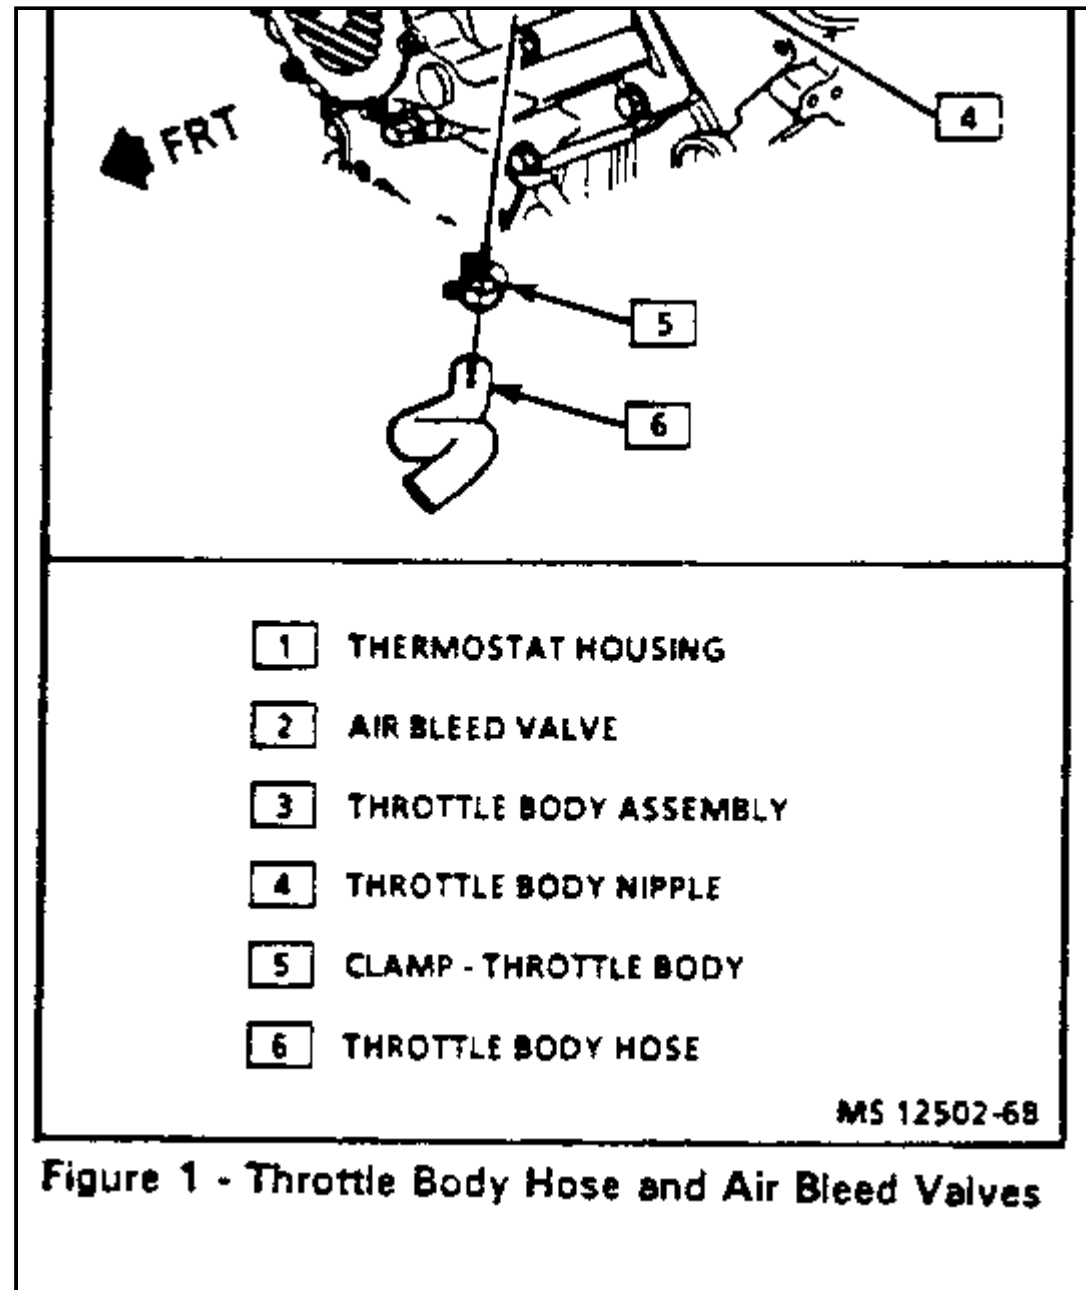
- B. Open radiator drain valve located at bottom of right-hand radiator end tank.
- C. Open air bleed valves on thermostat housing and throttle body unit (refer to Figure 1, page 6).
- D. Remove engine knock sensors from lower right-hand and left-hand sides of block.

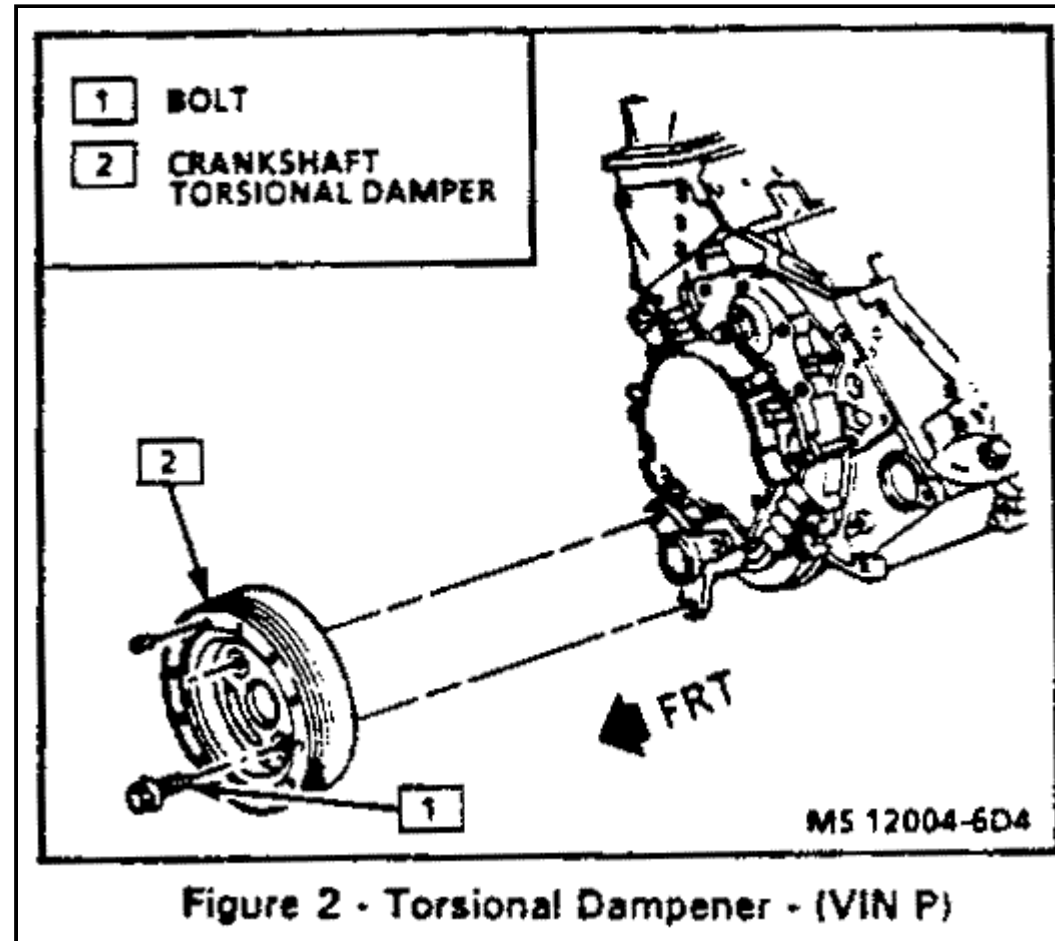
10. Remove three crankshaft torsional damper bolts and damper (refer to Figure 2, page 6).
 11. Disconnect spark plug (secondary) cables from distributor. Twist each boot 1/2 turn before removing, and pull only on boot to remove wire from distributor.

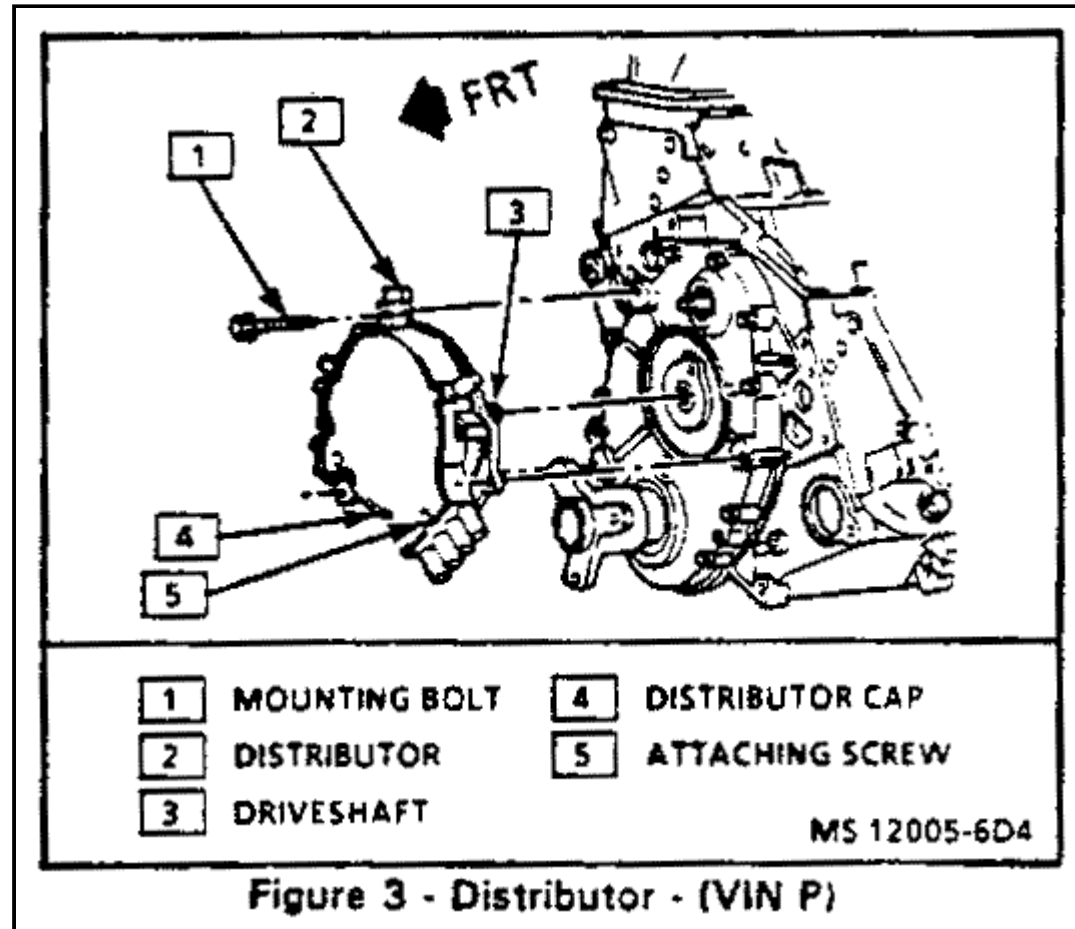
12. Disconnect four-terminal connector from distributor.
 13. Remove three distributor mounting bolts. Pull distributor forward until drive shaft disengages from engine. Mark top surface of shaft to denote location during re-assembly (refer to Figure 3, page 6).

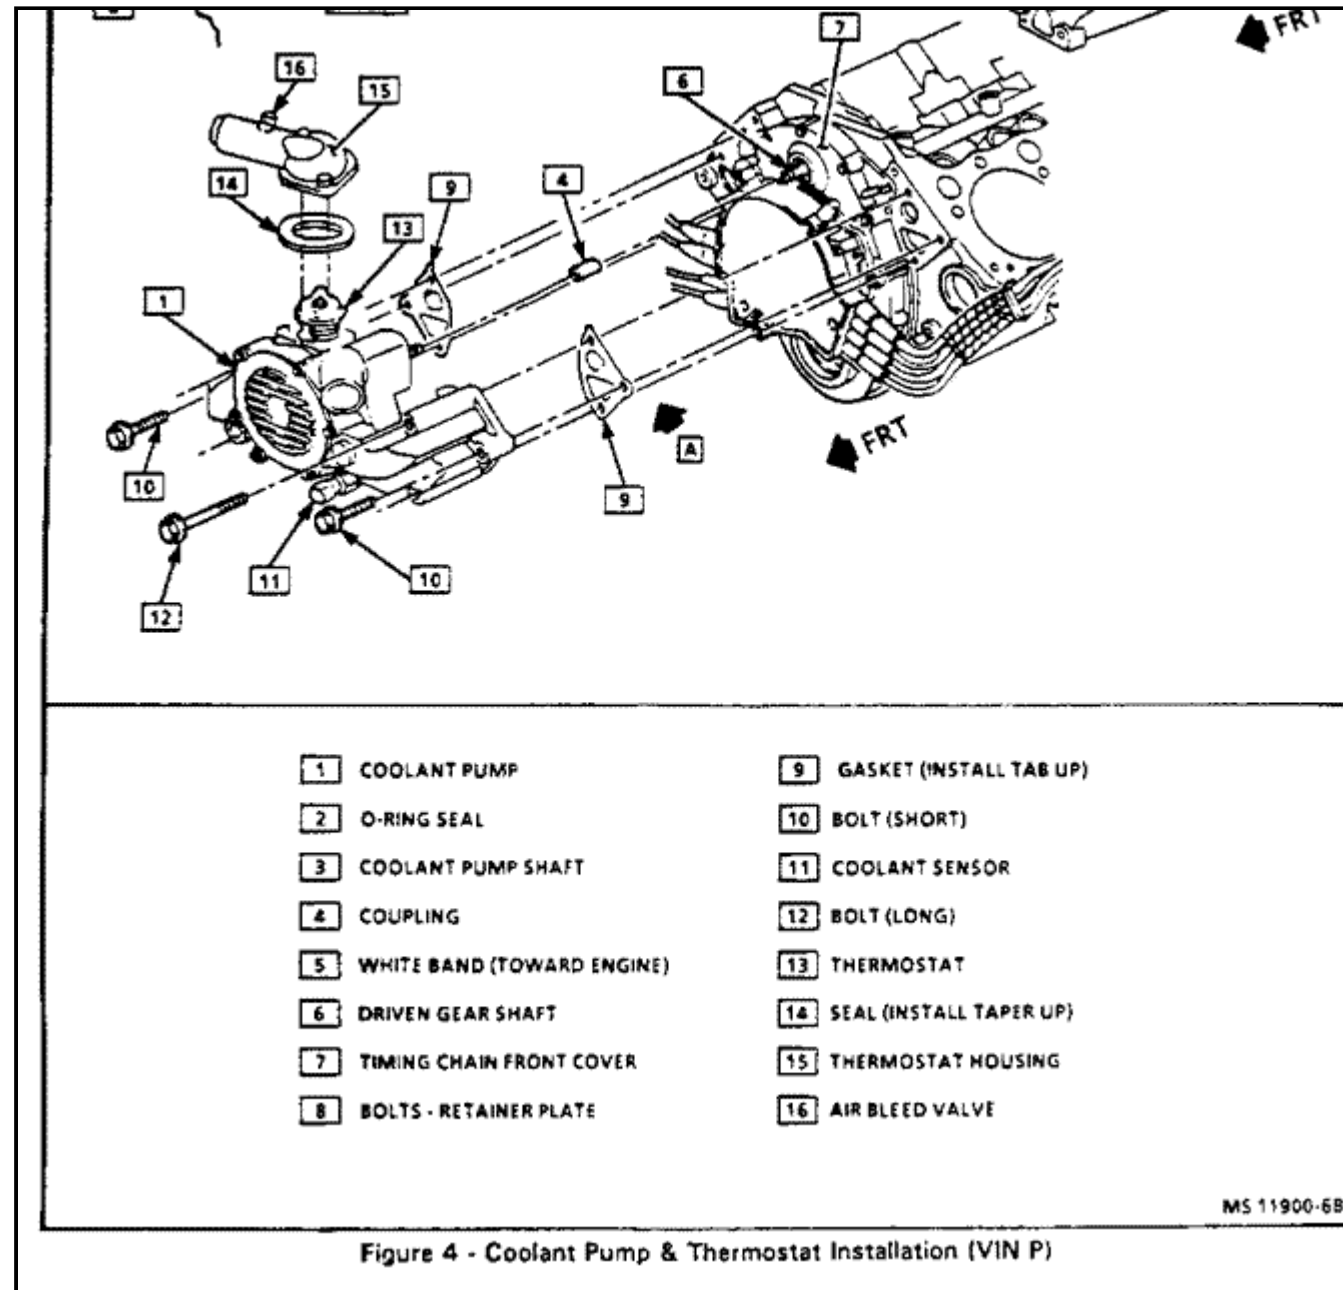
- C. Apply light coat of grease to seals and splines before assembly of coupling to coolant pump. White band on coupling goes toward engine (refer to Figure 4, page 7).
